**REPORT INTO
PEDESTRIAN SAFETY CONCERNS**

**In vicinity of Antrobus Road
and its access passageways to
Mossy Bank and Boldmere Spinney**

Prepared by Nick Curwen (Friends of Boldmere Spinney)

v-02 October 2024

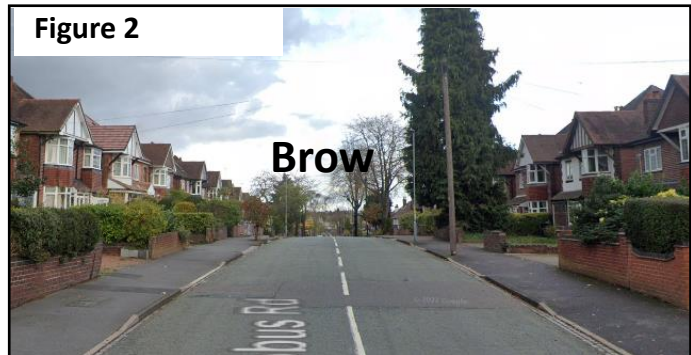
2.2 The road commences at a signal-controlled cross-road junction with A452 Chester Road and Court Lane, with an on-demand pedestrian phase. From this junction, the road climbs uphill for about 200 metres, before crossing over a ridge of higher ground (from Gibbet Hill to the north). The brow of the ridge looking towards Boldmere Road is seen in Figure 2.

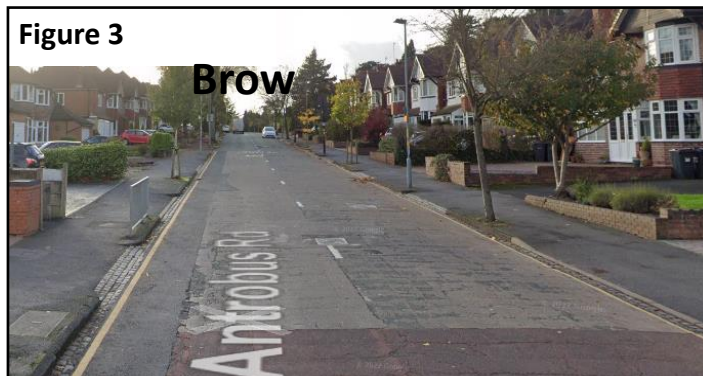
2.3 From this brow, Antrobus Road runs downhill, towards the crossing point area of concern, before continuing onwards, towards B1412 Boldmere Road. Figure 3 is a view backwards from the crossing point, towards the brow of the ridge, (the coloured surfacing just visible).

It is from this direction, most concerns about speeding traffic are raised. There are reports of pedestrians intimidated by the free-running downhill speeds of traffic.

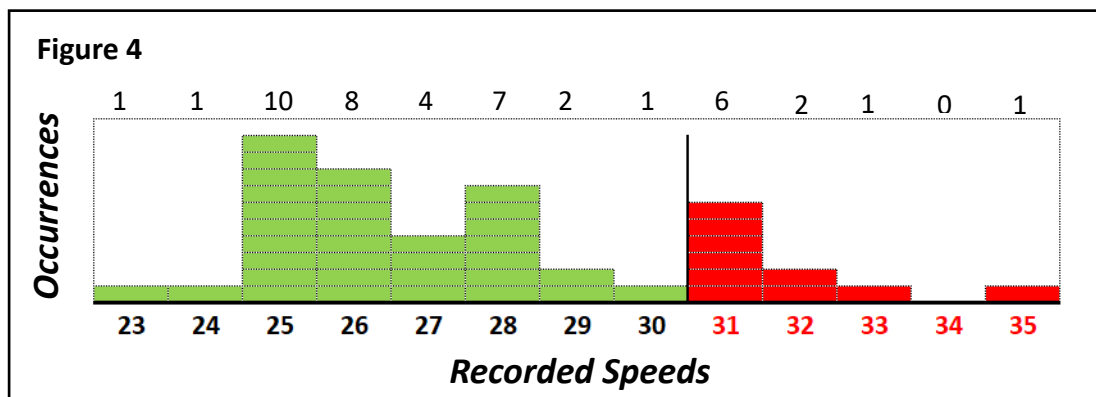
- 2.5 Despite any over-exaggeration, the results illustrated in Figure 4 illustrate how, overall, the speed detector is doing its job. It shows thirty-four, out of forty-four recorded peak speeds at or below the 30mph speed limit (taken over two 20-minute periods). Of the remaining ten, all but the two fastest drivers went on to moderate their speed down to, or below, the speed limit. On this basis, there is little evidence to justify any major concerns with non-compliance of the 30mph speed limit and some confidence a 20mph limit could see speeds drop further.

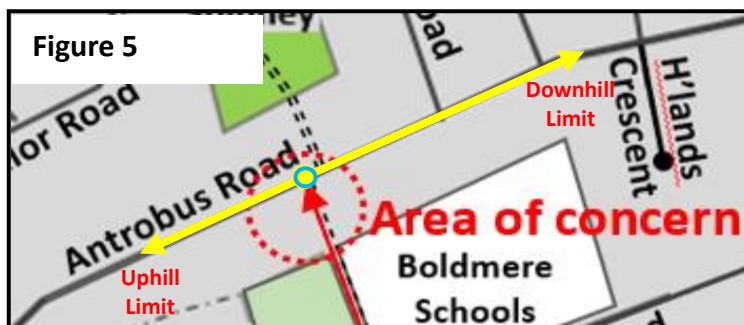
- 2.6 A non-speed-related reason for a misconception of speeding may be the result of the limited time pedestrians have, to see approaching downhill vehicles. When looking from the crossing point, the view of downhill approaching traffic is limited by the brow of the ridge, whilst the view of approaching uphill traffic extends significantly further, with vehicles visible from beyond the Ivy Road Junction as illustrated in Figure 5.

Thus, when downhill vehicles become visible, they appear far nearer to pedestrians wishing to cross than vehicles coming from the opposite direction. This closer proximity may explain the uncalled-for perception of significant speeding above the 30mph speed limit.

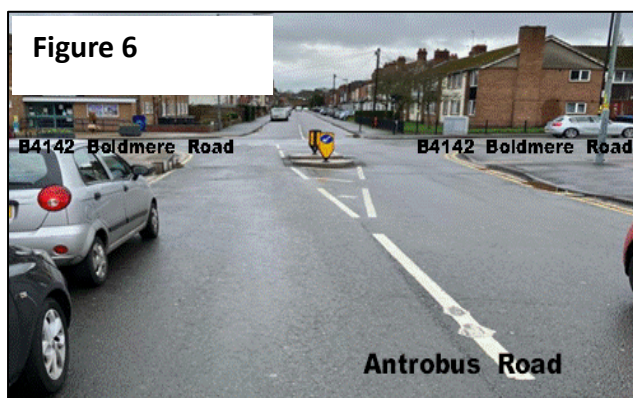
- 2.7 Reaching the far end of Antrobus Road, we have the priority B1412 Boldmere Road cross-road junction (with Highbridge Road). A pedestrian island has been installed on the-relatively flat approach to Boldmere Road as shown in Figure 6 (with Highbridge Road in the distance).

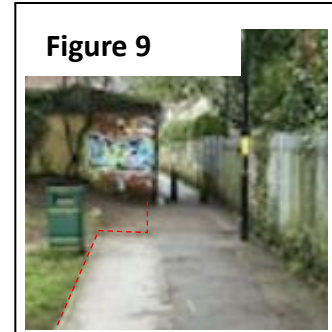
4.1 The approach to the passageway consists of circa 200-metre-long, c3.0-metre-wide footpath, with an open aspect to Mossy Bank and a high fence along the school boundary. This wide footpath physically narrows on the immediate approach to the passageway, but pedestrians ignore the lack of asphalt surfacing and simply walk on the adjacent ground, now devoid of grass (see Figure 9).

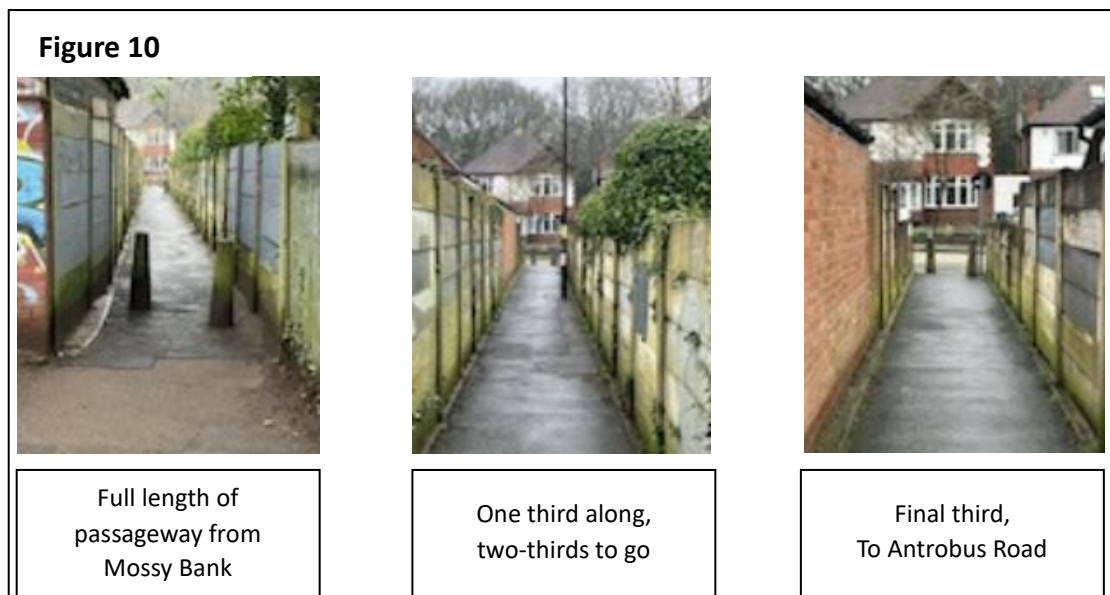
4.3 This passageway is particularly narrow in relation to its length and, despite the presence of a street light part way down, it is particularly unattractive and oppressive to users at any time. Recognising its physical constraints cannot be changed, the challenge is to ensure the best and safest use is made of what is available. A further two concrete bollards are positioned at the end of the 60-metre passageway, adjacent to the Antrobus Road footway (see Figure 10). In a similar fashion to those at the Mossy Bank end, these bollards restrict the width available to pedestrians.

- 4.5 The two bollards at Antrobus Road not only obstruct pedestrian flow, but represent a clear and unnecessary danger to those using the passageway during the after-school-peak. Pedestrians at the rear can only have very limited knowledge of what is happening ahead of them and in the event of a child falling over, could lead to injury as those in front of the incident are jostled forward. Even though it is for BCC to decide whether the benefits of either set of bollards, outweigh their disbenefits, there appears to be a strong case to remove these “exit” bollards, especially at Antrobus Road.

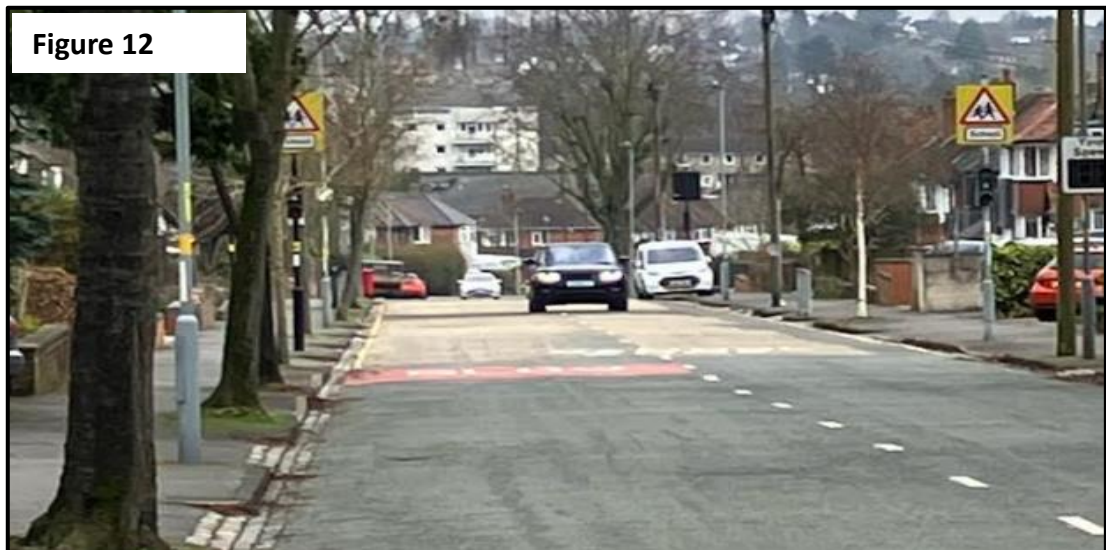
- 6.2 What is not immediately apparent from any plan, is the driver-view when approaching this crossing point, especially driving downhill from Chester Road. As shown in Figure 12, the downhill section of Antrobus Road has a line of trees, lamp posts and sign posts adjacent to the carriageway edge, all combining to obscure pedestrians waiting to cross and distract drivers. The safety barriers at the ends of the two passageways are not prominent and the presence of parked vehicles during school pick-up times further complicates the view drivers have. The free-flowing nature of the traffic also does little to encourage drivers to pay any heed to the needs of pedestrians.

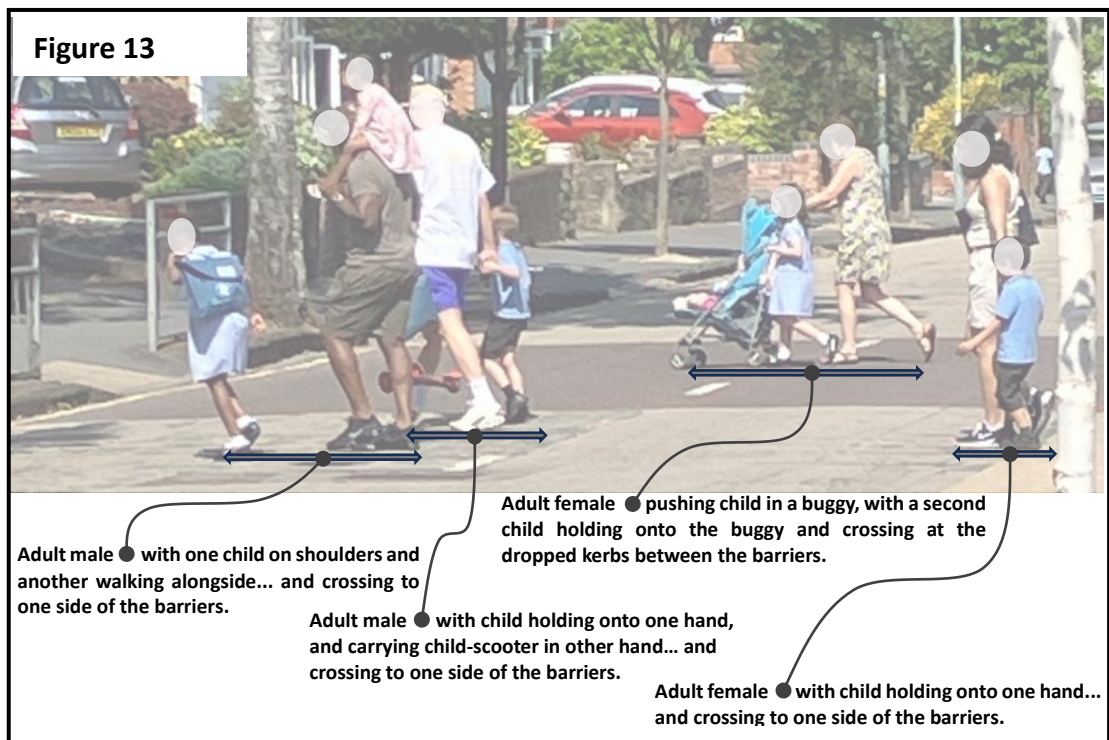
6.4 In the busier after-school peak; once exiting the Mossy Bank passageway, those waiting to cross Antrobus Road are faced with the daunting task of shepherding children across an 8-metre-wide road between gaps in traffic, after having been forced to find a place adjacent to the kerb in competition with other families also wishing to cross at the same time. This is illustrated in Figure 13, a photograph taken during the June 2024 hot weather just before the main body of children with their accompanying adults arrived to cross the road at the end of the school day.

6.5 Figure 13 clearly illustrates that what is taking place is not a sequence of crossings by individual pedestrians, but multiple crossings by groups of pedestrians... taking place at the same time and spread out along a section of road. Some issues are identified; as we have a mix of adults with children holding on (or not), a buggy, a child-scooter being carried and one instance of a piggy-back... and this was before it got busy. This pattern of behaviour will dictate what could be deemed practicable and workable interventions.

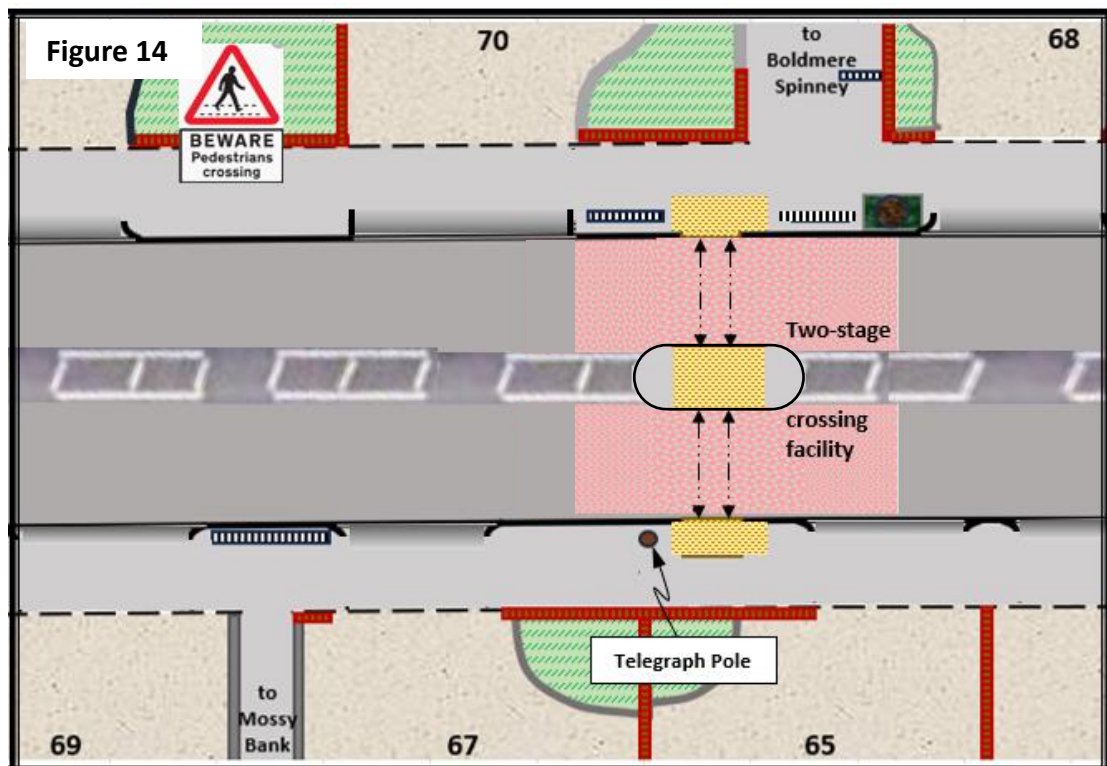
- 7.1 This is the first of two options considered for addressing pedestrian safety concerns. Both are based on the provision of a permanent 20mph zone from the Chester Road side of the ridge, to beyond the Oakwood Road junction, in conjunction with significant central white line hatching, to effectively reduce the carriageway width on the approach to the crossing point. Additional signing may also be necessary, depending on the options (shown indicatively on the option plans, bearing no relation to precise signs, nor their location).
- 7.2 The first intervention is to introduce a central pedestrian island (similar to that already existing on the Antrobus Road approach to Boldmere Road). The idea behind a central island layout shown in Figure 14, is to allow pedestrians to cross the road in two stages (layout shown more extensively in Annex B).

- 7.3 A central island would need to be wider and longer than shown here to accommodate multiple family groups arriving at the same time. This is simply not possible and, if a lesser facility were to be introduced (as shown here), there is a real risk it would be ignored, with people forced to cross the full width of this 8-metre-wide road in a single movement.
- 7.4 Not only would a central pedestrian island of insufficient dimensions do nothing to address safety concerns of those crossing Antrobus Road, it could provide an additional obstacle and make the current situation worse. It would also contribute nothing to resolving concerns about the Mossy Bank passageway or its outflow onto the footway. On this gloomy note we consider the second intervention.

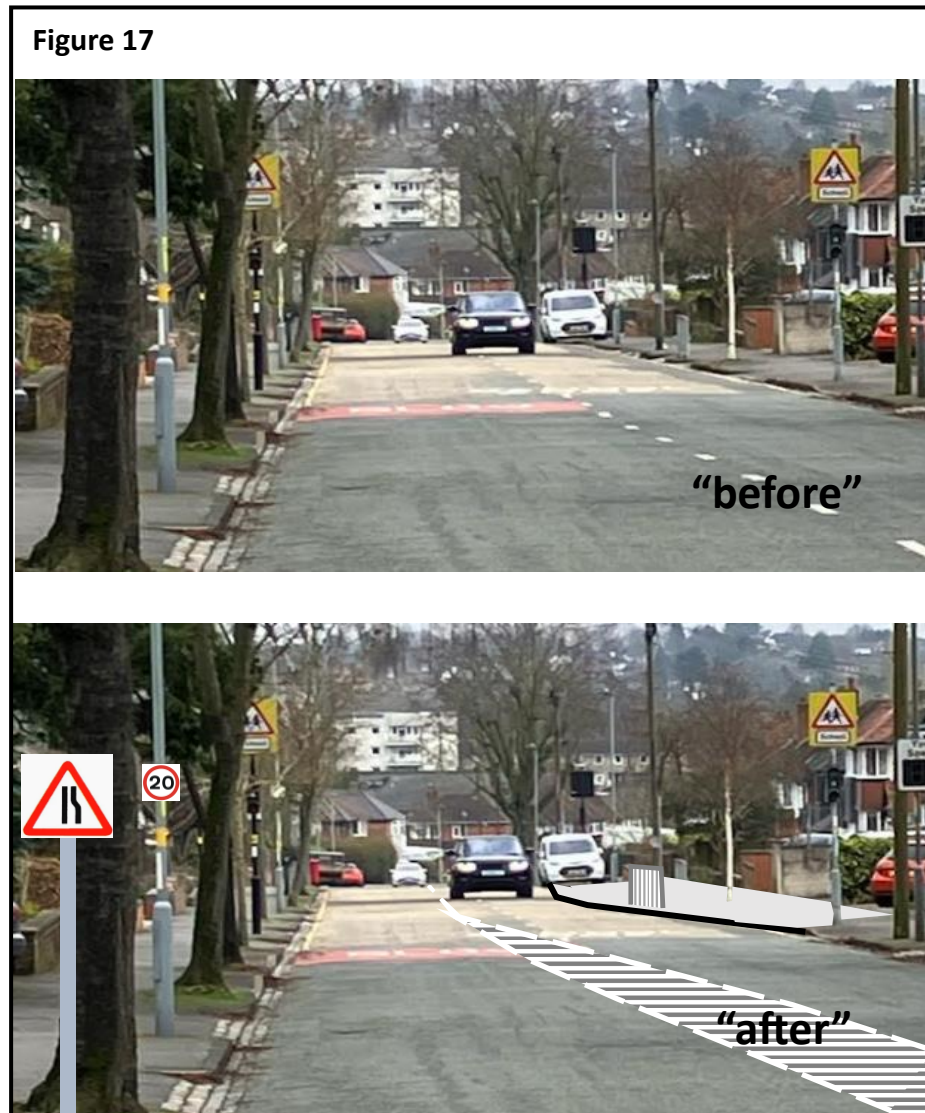
- 8.4 This is the one solution that may address all the concerns and not just those about crossing Antrobus Road. To complete this assessment, “before” and a possible “after” layouts are illustrated by Figure 17.

- 8.5 The layout shown above represents the minimum narrowing to benefit all pedestrian activity. However, if it were deemed necessary to **maximise the area of pavement** opposite the entrance to the Mossy Bank passageway, the road narrowing could be extended uphill as illustrated by the layout shown in **Annex C(i)** (an alternative to Annex C). Such a layout would maximise the benefit for those pedestrians exiting the passageway under pressure, whilst adding little in the way of extra burden to motorists.

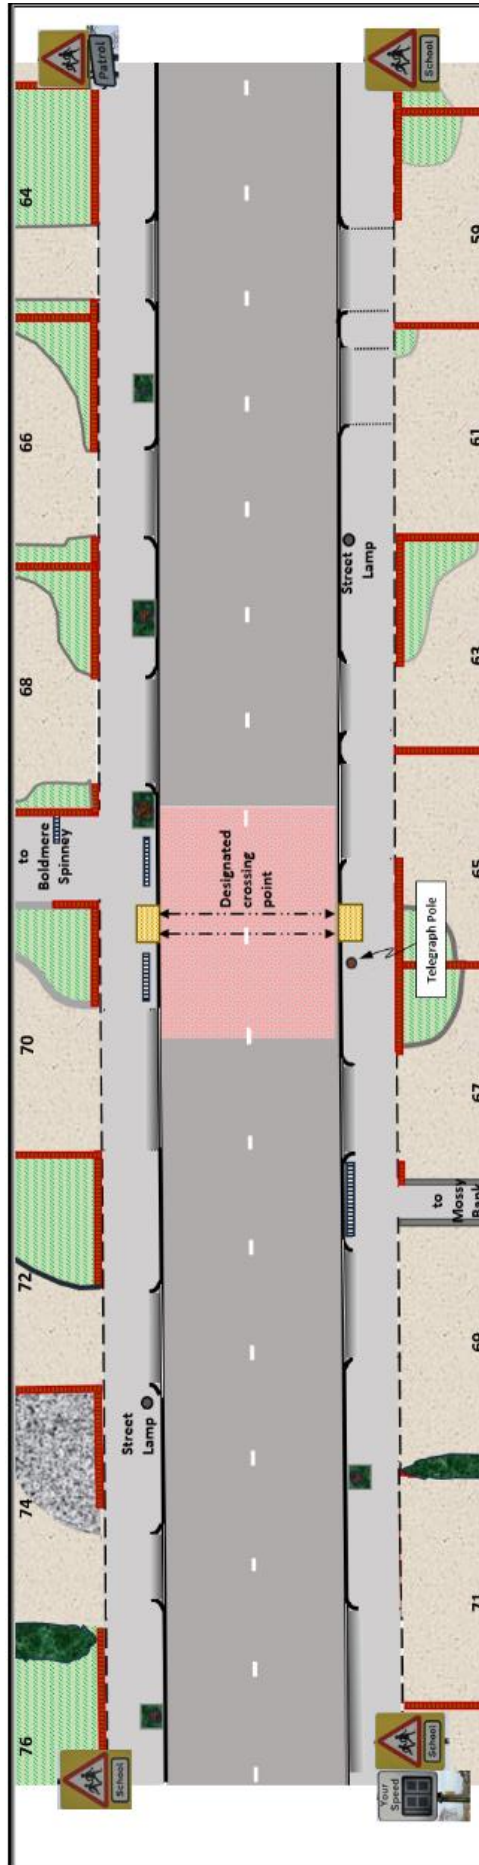
ANNEX A:

Existing Layout

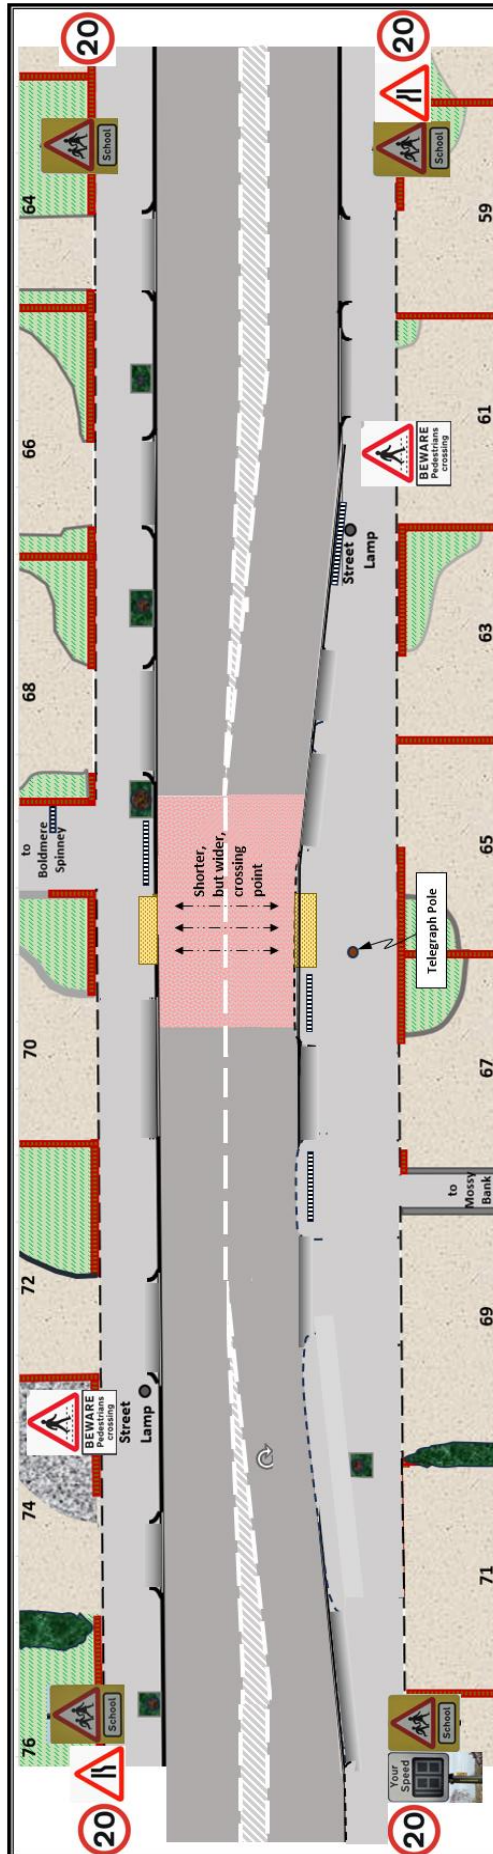
ANNEX C (i):

Localised
Road Narrowing
Option – MAXIMISED
